# **Nevada Northern Railroad Project Engineering Study and Cost Estimate**

## **City of Ely, Nevada**

**R.L. Banks & Associates, Inc.**

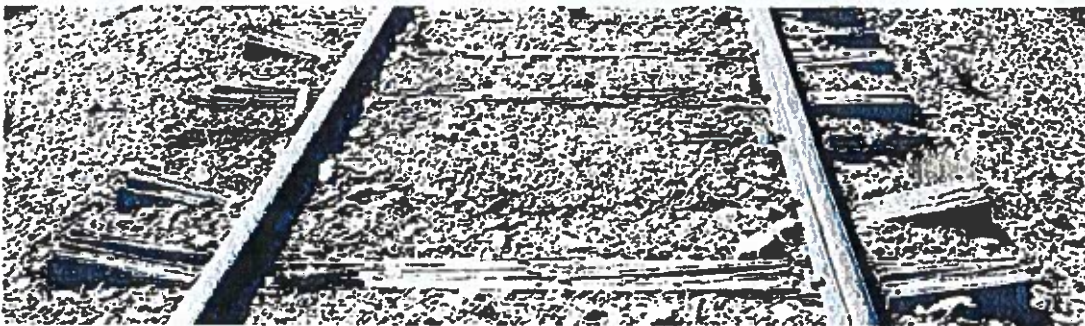
*Figure 2 – Scrap Ties on the NNR*

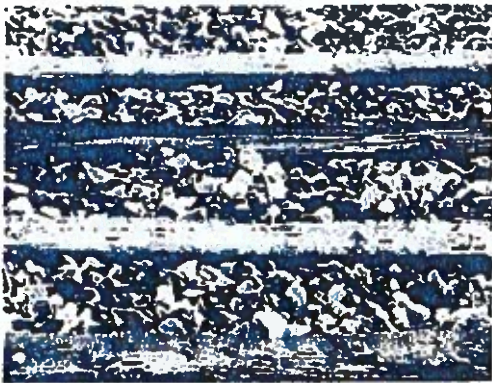
**Figure 5 – Good Quality Ballast at UPRR Shafter Siding**

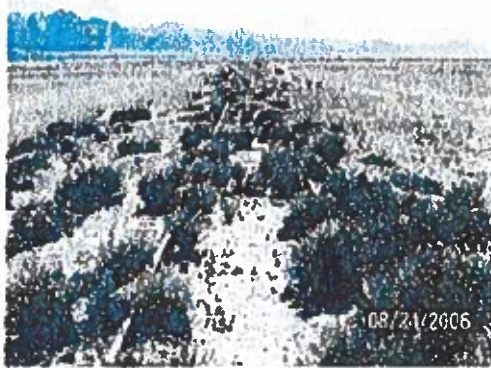
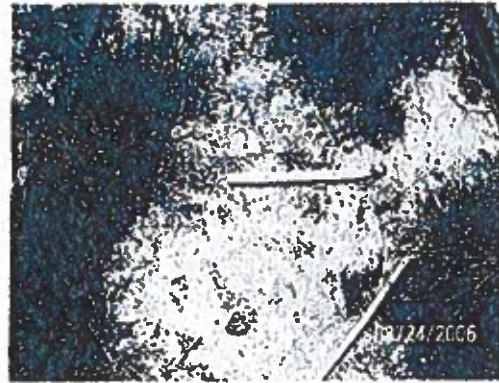
**Figure 9 and Figure 10 – Native Silt Material In Rail Bed**

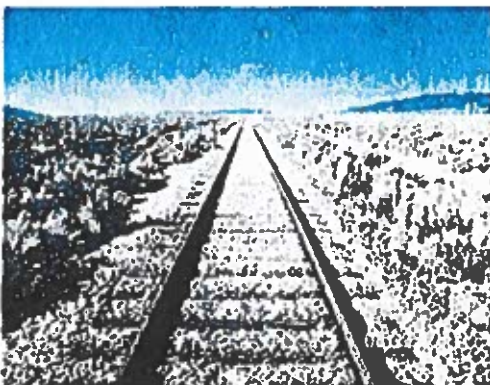
North of MP 61, vegetation in the ballast is generally non-existent to scattered in most locations, as shown in Figures 11 and 12. South of MP 61, vegetation in the ballast is generally moderate to heavy in most locations and native soils are frequently found in the ballast section, as seen in Figures 13 and 14. All vegetation will need to be eliminated before unit trains commence operating on the NNR.

**Figure 11 – No Vegetation**

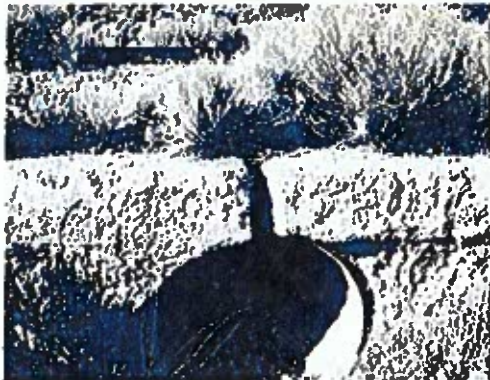
**Figure 25 and Figure 26 – Rusted Culvert with Shallow Cover**

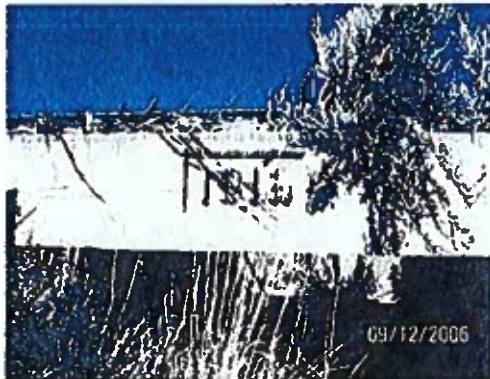
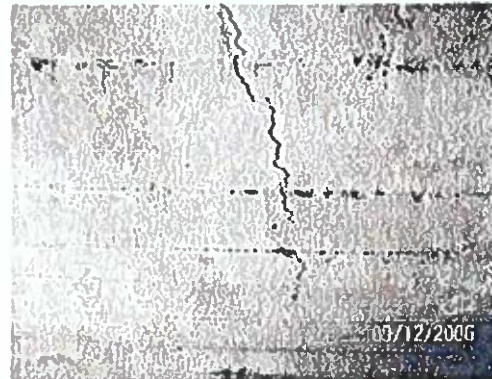
**Figure 27 and Figure 28 – Cracked Concrete Box Culvert / Bridge**

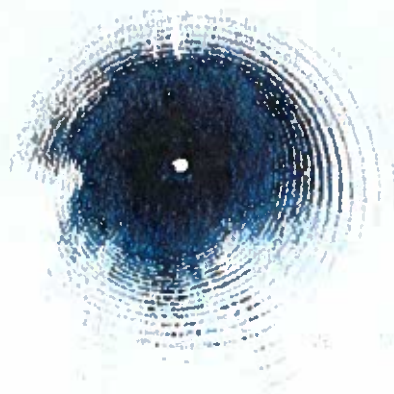
Some culverts appear to be in fair condition from the inside. However, it is unknown if these culverts are decaying from the outside due to "hot" acidic soils or other factors. Some of the CMPs appear to have rust creeping from the outside in and are located in areas that do not appear to have standing water. This may be due to hot soils in those areas. Figures 21-29 depict typical culvert conditions.

**Figure 29 – CMP that Appears to be in Fair Condition from the Inside**

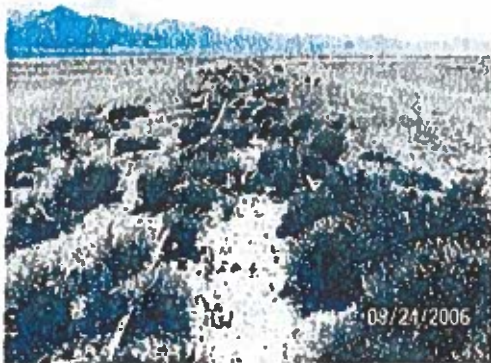
There are several natural drainage paths that cross NNR's alignment. Some areas, particularly on the south end of the alignment, appear to have an inadequate number of culverts to convey water under the railway, thus creating potential areas for stormwater to pond. A few drainage paths traversing perpendicular to the rail alignment are found to be lacking culverts. In some other locations, the flow lines of the existing culverts are much higher than the natural ground surface, also creating areas for stormwater to pond. Figures 30 and 31 depict these conditions.

*Figure 30 – MP 93-108 Needs Culverts*

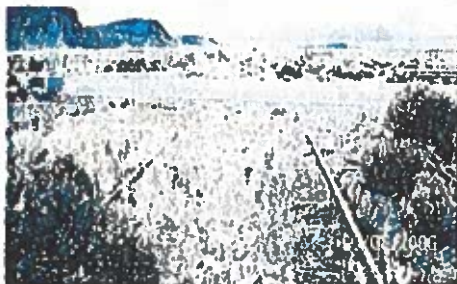
All road crossings along the NNR from MP 18.5 to MP 120 are at-grade crossings. Two of the crossings are asphalt highway crossings at Currie and Cherry Creek (MP 63 and MP 91, respectively). These crossings appear to have fair advanced warning signs and paint markings but inadequate signage or signaling for an active rail line. Neither crossing has concrete or timber crossings between or around the rail per current UPRR specifications. Figures 32 and 33 show these road crossings. As seen in Figure 32, the Currie crossing has been completely asphalted over.

*Figure 32 – Currie (MP 63) Road Crossing*

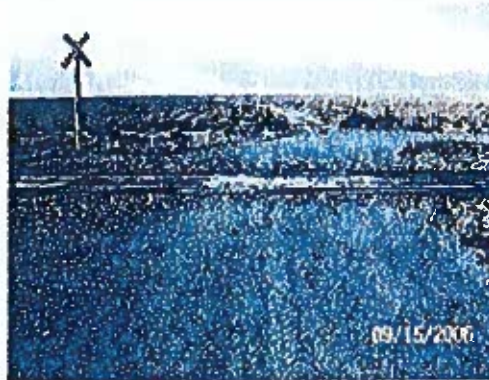
**Figure 34 – Good Timber Crossing on the UPRR Main Line**
